Service Bulletin

Bulletin No HUK000000000844

Service News (Issue 2) Helping you fix it right the first time

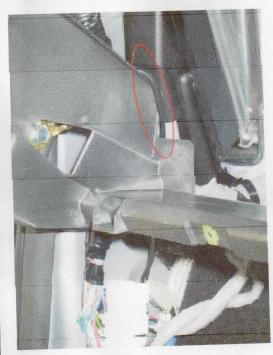
Check the sub feeder harness as it may have been mis-routed as shown in the example below.

If the feeder harness has been mis-routed, then this may cause tension on the sub feeder, which pulls the cable out of the coupler causing a short between the core and the shield.

To repair this problem, replace the sub feeder harness, ensuring it is routed correctly.
