Model	Model Code	Year Model	Issue Date
CIVIC 3D	FN1, FN2, FN3	07, 08	13-05-08
CIVIC 5D	FK1, FK2, FK3	06, 07, 08	Originator Product Technical/QIC Product Technical/QIC

Civic: Noise from Front When Accelerating or Braking

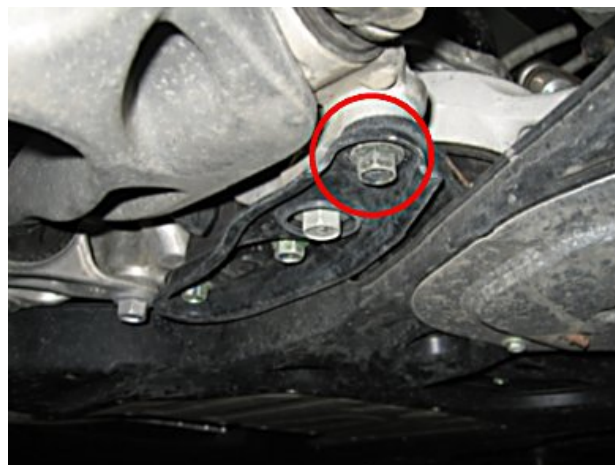
- Raise the front of the vehicle.
- Remove the bolt highlighted from the Stiffener Right Front Subframe.

- Test vehicle at **low speed** by sharply applying brakes / hard acceleration. (Noise can be heard braking from speed as low as 3mph.
- If it is no longer possible to reproduce the noise with the bolt removed then proceed with repair in this bulletin.
- If the noise is still evident, continue with normal diagnosis.

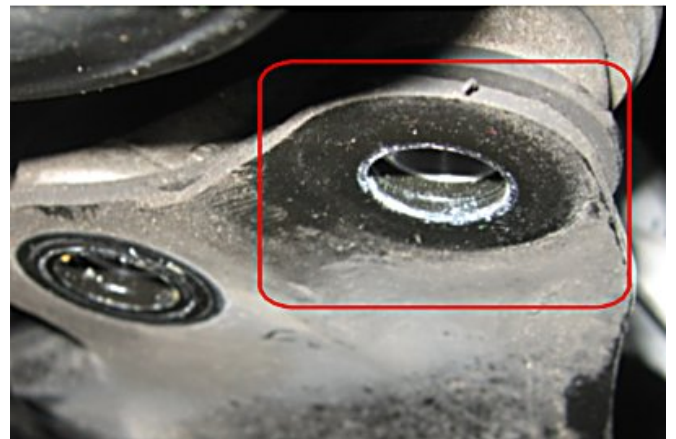
Build up of dirt between the two sections of the vehicle subframe. This causes the two sections to 'stick-slip' under the application of braking or acceleration forces.

- Clean and thoroughly degrease area (use brake cleaner or similar) between two parts of subframe. Blow out any debris etc with compressed air.
