Service Manual Update: Power Window Goes Up and Reverses On Its Own, Is Slow to Open and Close, or Squeals, Creaks, Clunks, or Clicks

The information in this service bulletin addresses three power window problems that are not currently covered in the service manuals.

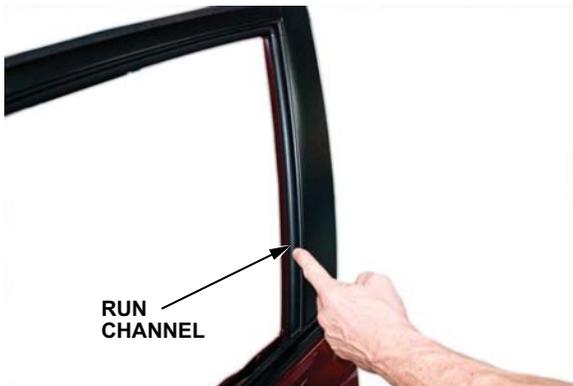
2. Inspect the visible portion of the run channel for damage.
 - If the run channel is visibly damaged, replace it, then recheck the window speed.
 - If the run channel looks OK, go to step 3.

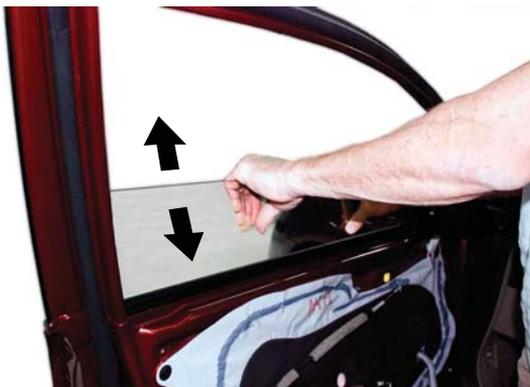
3. Reinstall the glass into the door without bolting it to the regulator, then manually slide it through its range of travel and check for excessive resistance:
 - If the resistance is excessive, go to step 4.
 - If the resistance is not excessive, go to step 5.

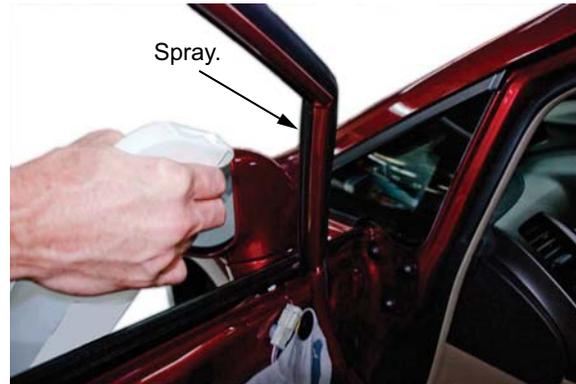
4. Inspect the run channel alignment, both inside and outside the door. Pay close attention just below the door skin; this is a common area for the run channel to be pinched.
 - If the run channel is pinched, replace it, then adjust the run channels and the glass as needed.
 - If the run channel is not pinched, go to step 5.
5. Clean the run channel using a soapy water solution, then apply Shin-Etsu grease. You may also need to clean the portion of the run channel within the door.

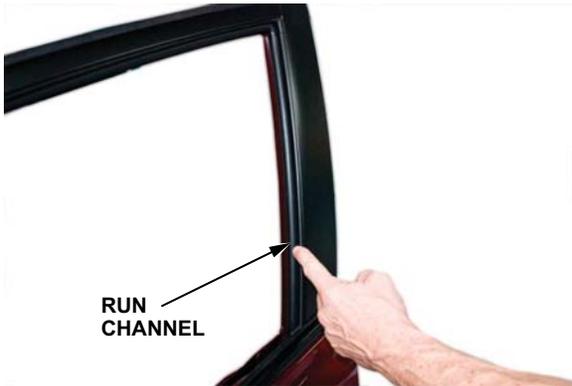
1. Compare the window's noise level to another like vehicle:
 - If the noise is the same, no repair is needed. Advise the customer that some noise is a normal characteristic.
 - If the noise is different from the other vehicle, go to step 2.
2. Inspect the run channel for damage.
 - If it is damaged, replace it, then recheck the noise level.
 - If the run channel is not damaged, go to step 3.

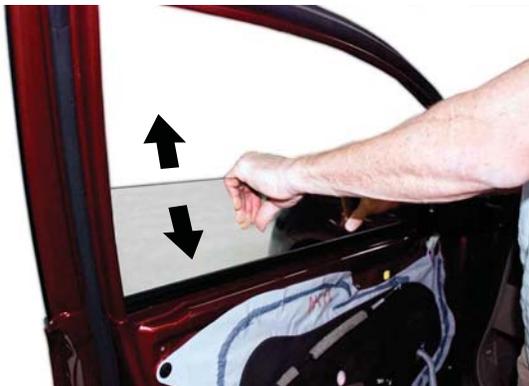
3. Remove the door panel.
4. Unbolt the glass from the regulator, then manually slide it through its travel to check for excessive resistance.
 - If the resistance is excessive, go to step 5.
 - If the resistance is not excessive, go to step 6.

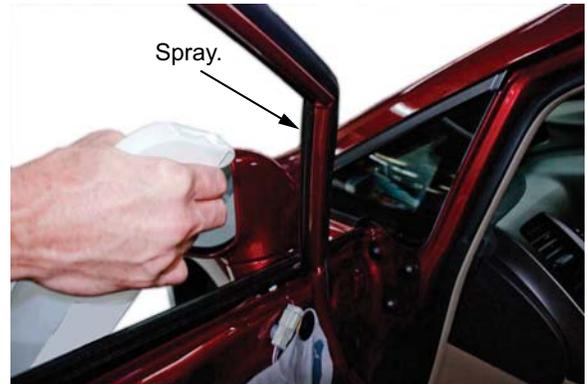
5. Clean the run channel using a soapy water solution, then apply Shin-Etsu grease inside the channel. You may also need to clean the portion of the run channel within the door.
 - If the window operates normally after cleaning and applying grease, no further action is required.
 - If the window noise symptoms are still present, go to step 6.
